**Docket No. 217 – Development and Management Plan Inspection**

Northeast Utilities Service Company Certificate of Environmental Compatibility and Public Need for the construction of a 345-kV electric transmission line and reconstruction of an existing 115-kV electric transmission line between Connecticut Light and Power Company's Plumtree Substation in Bethel, through the towns of Redding, Weston, and Wilton, and to the Norwalk Substation in Norwalk, Connecticut.

**Date:** June 29, 2005

**Location:** 345 kV Underground Route

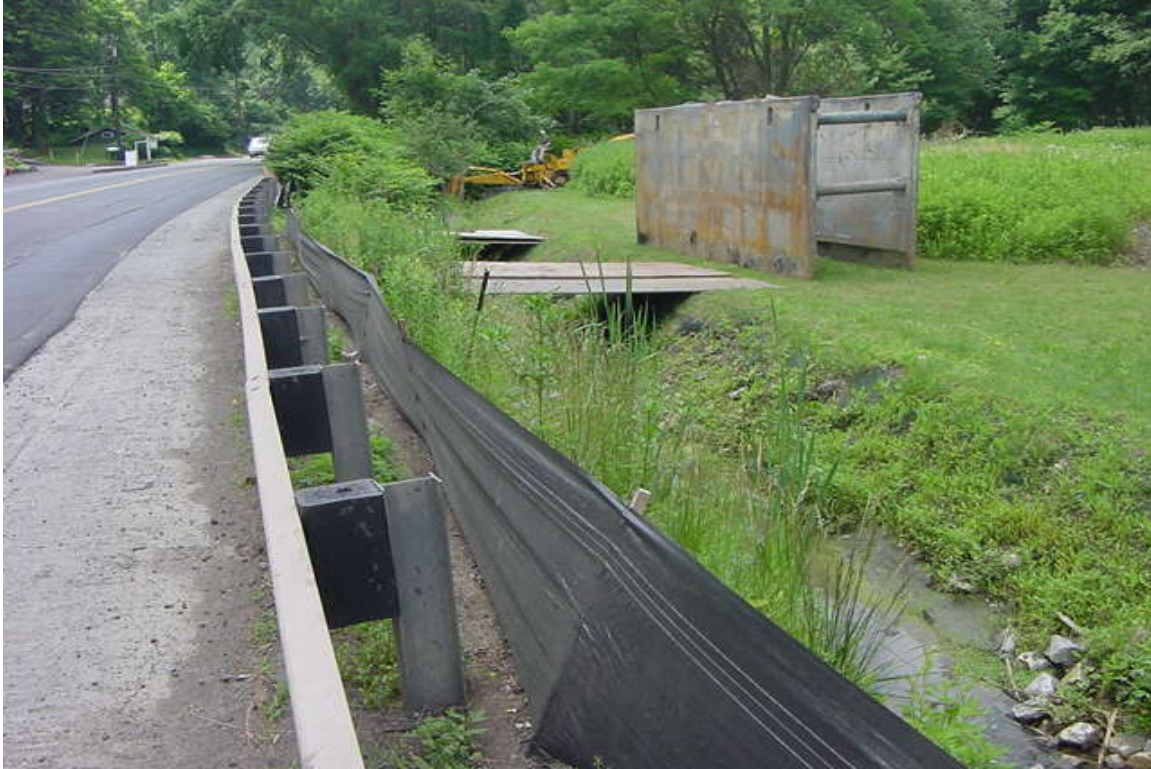
Storage area off Route 7 in Wilton. The excavator should be moved away from wetlands during inactive hours. 6/29/05

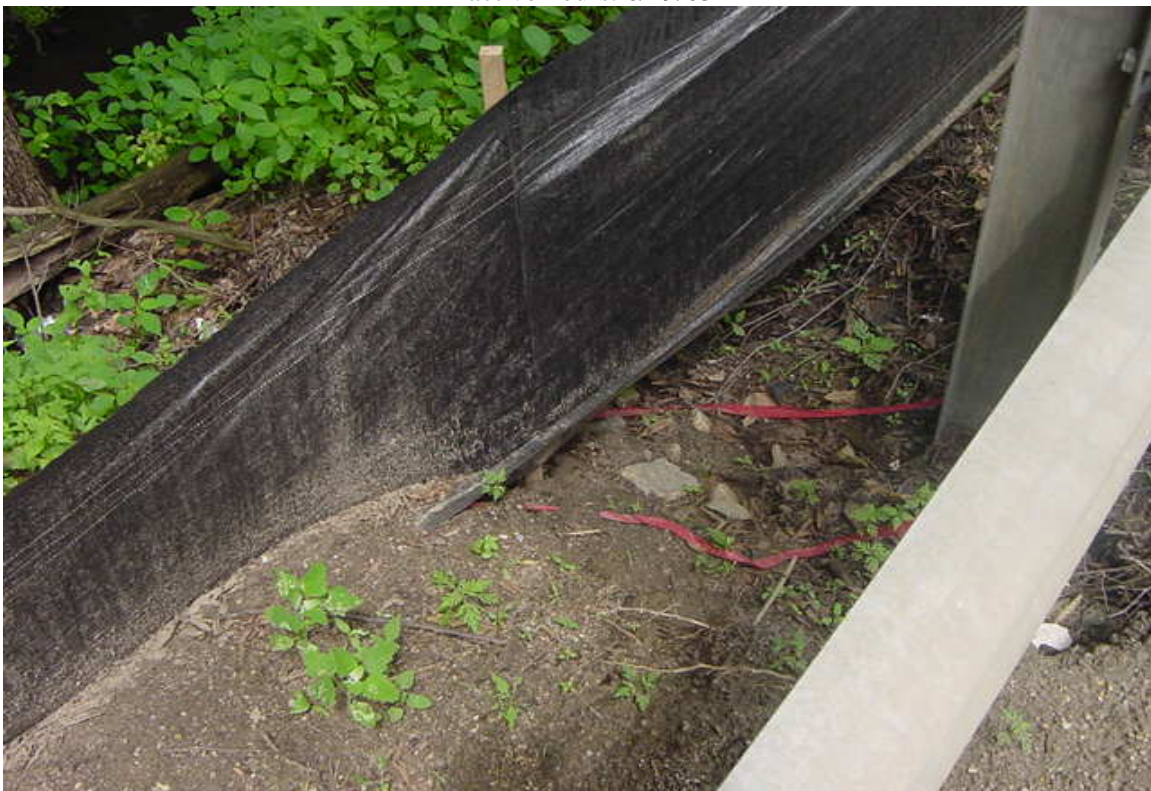
| Areas of Inspection | Observation | Recommended Action |
|---|---|---|
| Erosion and Sediment Controls<br>(includes inspection within 24 hours of a storm event) | - Silt fence remained installed in the areas of active work along Rt. 7 where wetlands are located adjacent to the roadway. 6/09-6/29/05<br><br>- The spot which has been signaled in previous reports, located to the south of the equipment storage yard (along Rt. 7) still has silt fence which has not been towed in accurately. A large gap was left where the topo drops into a road drainway. The contractor has attempted to make repairs here but there was some confusion between them and the area indicated in the report. 6/29/05 | - Continue to monitor and maintain and repair the fence when necessary. 6/09-6/29/05<br><br>- A stream and wetland were located downgradient of this silt fence and they would not be protected from any run off. The fence should be repaired prior to active work in this area. 6/29/05 |

Area of silt fence along Route 7 signaled in the report for a few weeks. A several inch gap remains below the fence. 6/29/05

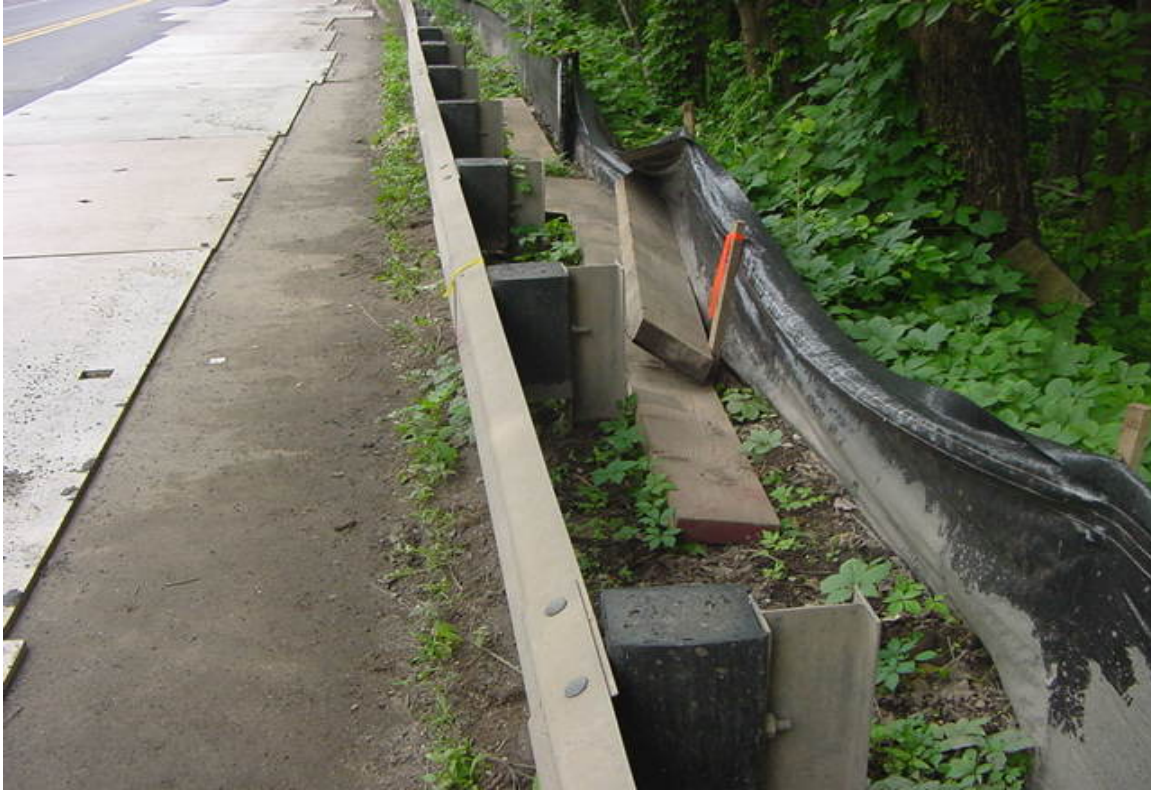
Additional view of the silt fence along Rt. 7 adjacent to the active work. Make sure all silt fence is toed in. 6/29/05

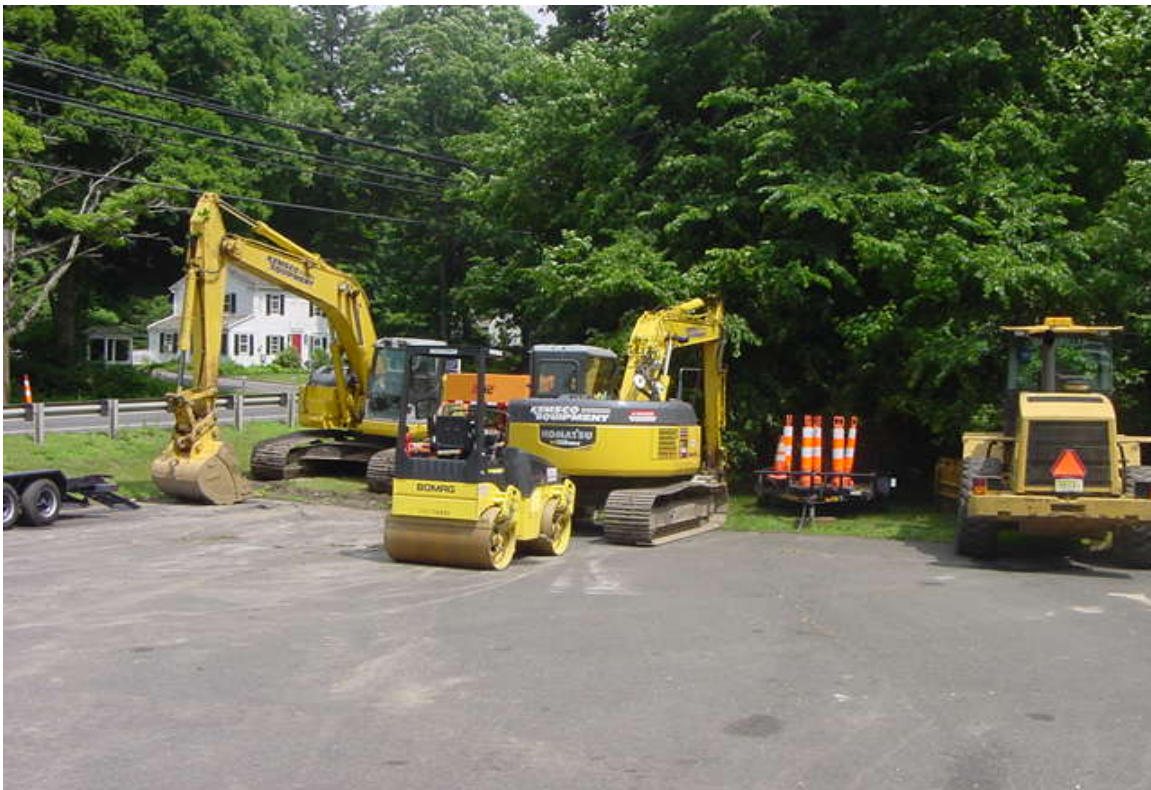
View of the equipment parking area in the lot of the United Methodist Church. 6/29/05
